NREC Report No. 1296-1
U. S. COAST GUARD LIGHTWEIGHT
FIRE-FIGHTING MODULE

Final Report

May 15, 1980

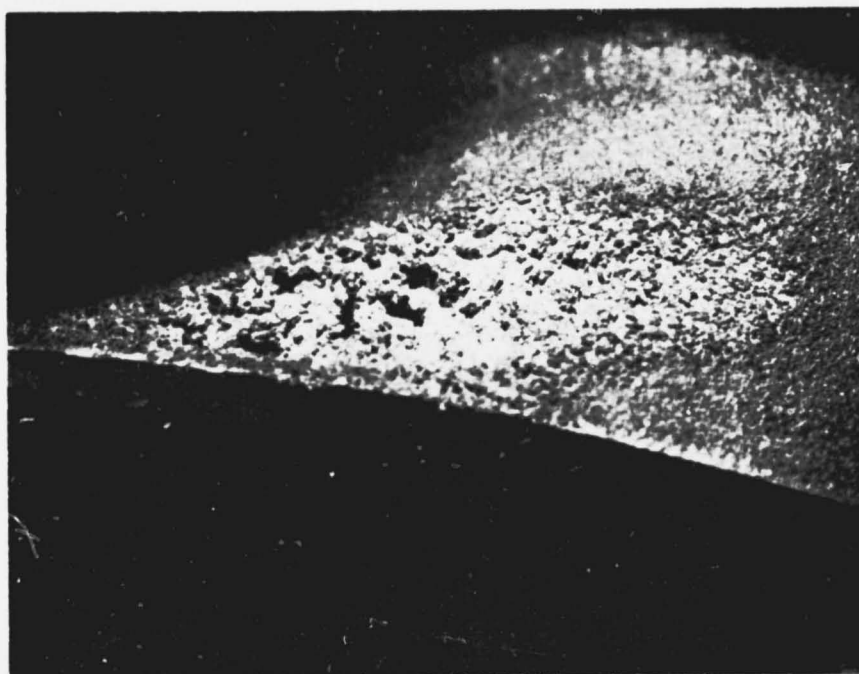
FIGURE 13 - PHOTOGRAPHS OF MAIN IMPELLER
AFTER 45 HOURS ENDURANCE TEST

After suspension of the endurance test on February 27, the pump was disassembled and inspected. It was discovered that the main impeller had lost a 2 in segment of one blade tip through fatigue fracture and had suffered severe pressure-surface cavitation damage. Photographs of the main impeller are reproduced in Figure 13. The pressure-surface cavitation on the main

impeller is thought to be caused by negative incidence on the blades. This could in turn be caused by operation at excessive flow rates or, more likely, by distortions in the flow into the main impeller inlet due to upstream geometry and flow in the inducer stage. The lost impeller blade tip shows evidence of fatigue fracture. Another blade shows a small crack starting. Blade fatigue cracking could only occur under blade pressure loading not seen in normal operation. This excessive loading may be associated with the severe pressure-surface cavitation or, alternatively, with unbalanced peripheral pressure fields at low flow rates.

b. Closeup of Broken Vane

c. Fatigue crack, root of blade near tip

d. Cavitation damage, pressure surface

e. Cavitation damage, suction surface root

f. Breakthrough into suction surface

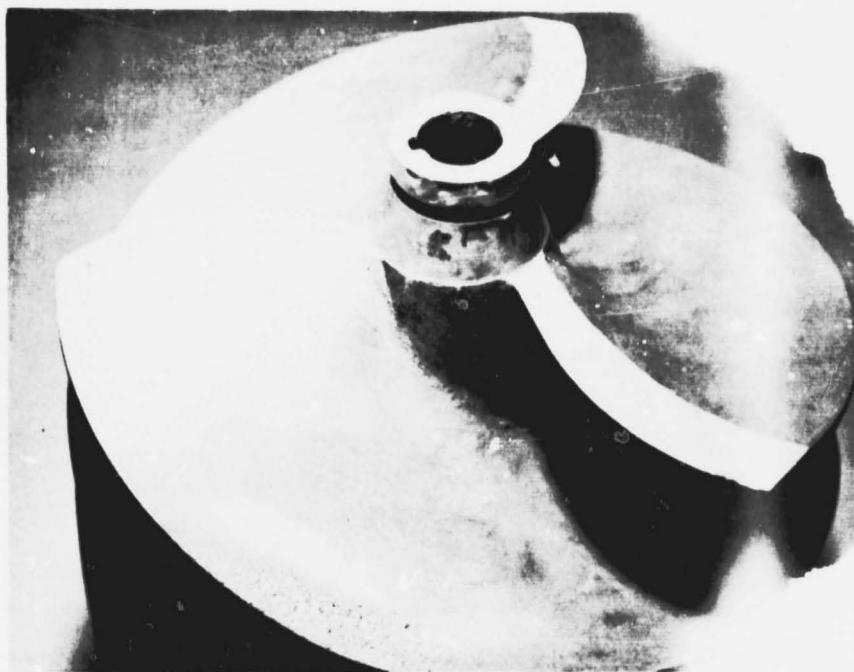
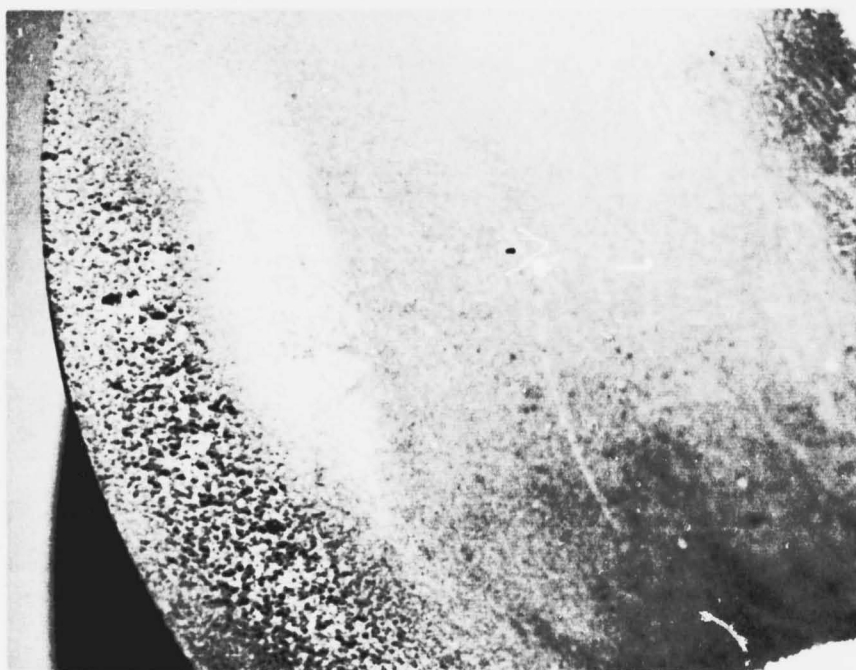
FIGURE 14 - PHOTOGRAPHS OF INDUCER IMPELLER
AFTER 45 HOURS ENDURANCE TEST

The inducer impeller showed slight suction-surface cavitation damage on one blade; the shape of the inlet of this blade had been changed by grinding (done to balance the impeller); this changed shape is thought to be responsible for the inducer cavitation damage; grinding at this location will be avoided in the future. Photographs of the inducer impeller are reproduced in Figure 14.

b. Closeup of Cavitation Damage

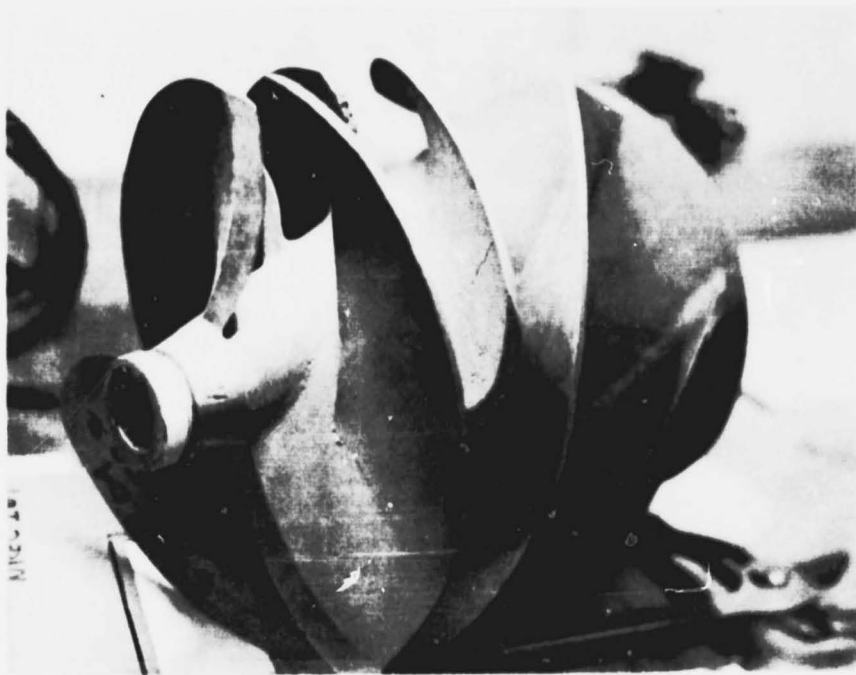
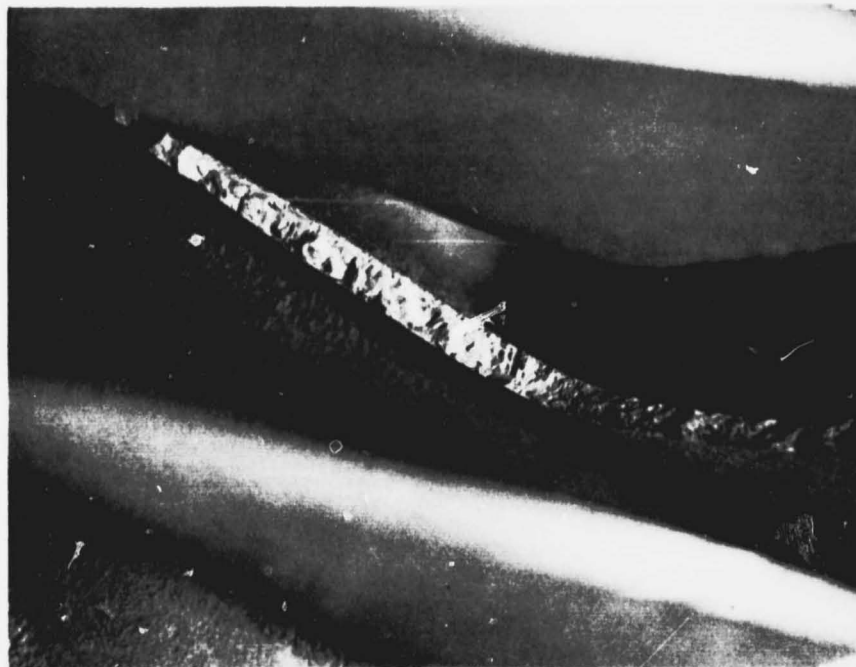
FIGURE 17 - INDUCER AFTER BLADE FAILURE

Blades cracked on two inducers during the August endurance test series. Photographs of a failed blade are shown in Figure 17. The first inducer to fail had been run on the pump for a total of approximately 34 hrs. After the first 25 hrs (8 hrs performance plus 17 hrs endurance) a hairline crack near the blade root was observed. This crack did not extend to the edge of the blade. The blade was weld repaired and the inducer put back in service. A failure of the type shown in Figure 5 occurred after an additional 9 hrs of running (2 hrs performance plus 7 hrs endurance). The failure was located at the weld repair. The first inducer was then removed from the pump and replaced by a second inducer.

The second inducer had operated for approximately 55 hours on the pump in January and February, 1978, when the low-speed interstage gears were still installed in the pump. At the time of reinstallation it appeared to be in excellent condition with only minor cavitation damage on one blade. This inducer experienced a failure similar to that of the first inducer after an additional 6 hrs of endurance testing.

In both inducers the failure appears to have started as a small crack near the blade root at a location about three inches downstream of the leading edge of the blade. The crack then propagated along the hub and eventually out to the blade shroud edge about one-third of the way from the leading edge to the trailing edge.

A thorough investigation of the cause of inducer blade failure was completed in September. Experimental measurement of blade dynamics in air at the NREC laboratory showed natural frequencies at 164, 365, and 998 Hz. The first two of these frequencies correspond to four and eleven times the rotating frequency of the inducer at the normal speed of operation. As there is a significant energy component in the fourth harmonic and as there are eleven stator vanes downstream of the inducer, these two resonances may easily be excited. Examination of the blade root thicknesses showed that in the region of the fracture the blades were typically 0.11 to 0.12 ins thick, whereas the design thickness is 0.25 ins. This decrease in thickness causes a large increase in the stress at the root above the nominal design value. On the above basis, the steady-state root stress was estimated to be 23,000 psi and the vibratory stress 4,000 psi. For the aluminum A356 cast blades these stresses are high enough to cause rapid failure by fatigue cracking.

Measurement of blade natural frequencies and analysis of the probable failure mechanism were undertaken. NREC decided that the gears should be changed in the pump and the inducer operated at the original lower speed, where it appeared to be capable of operating without failure.

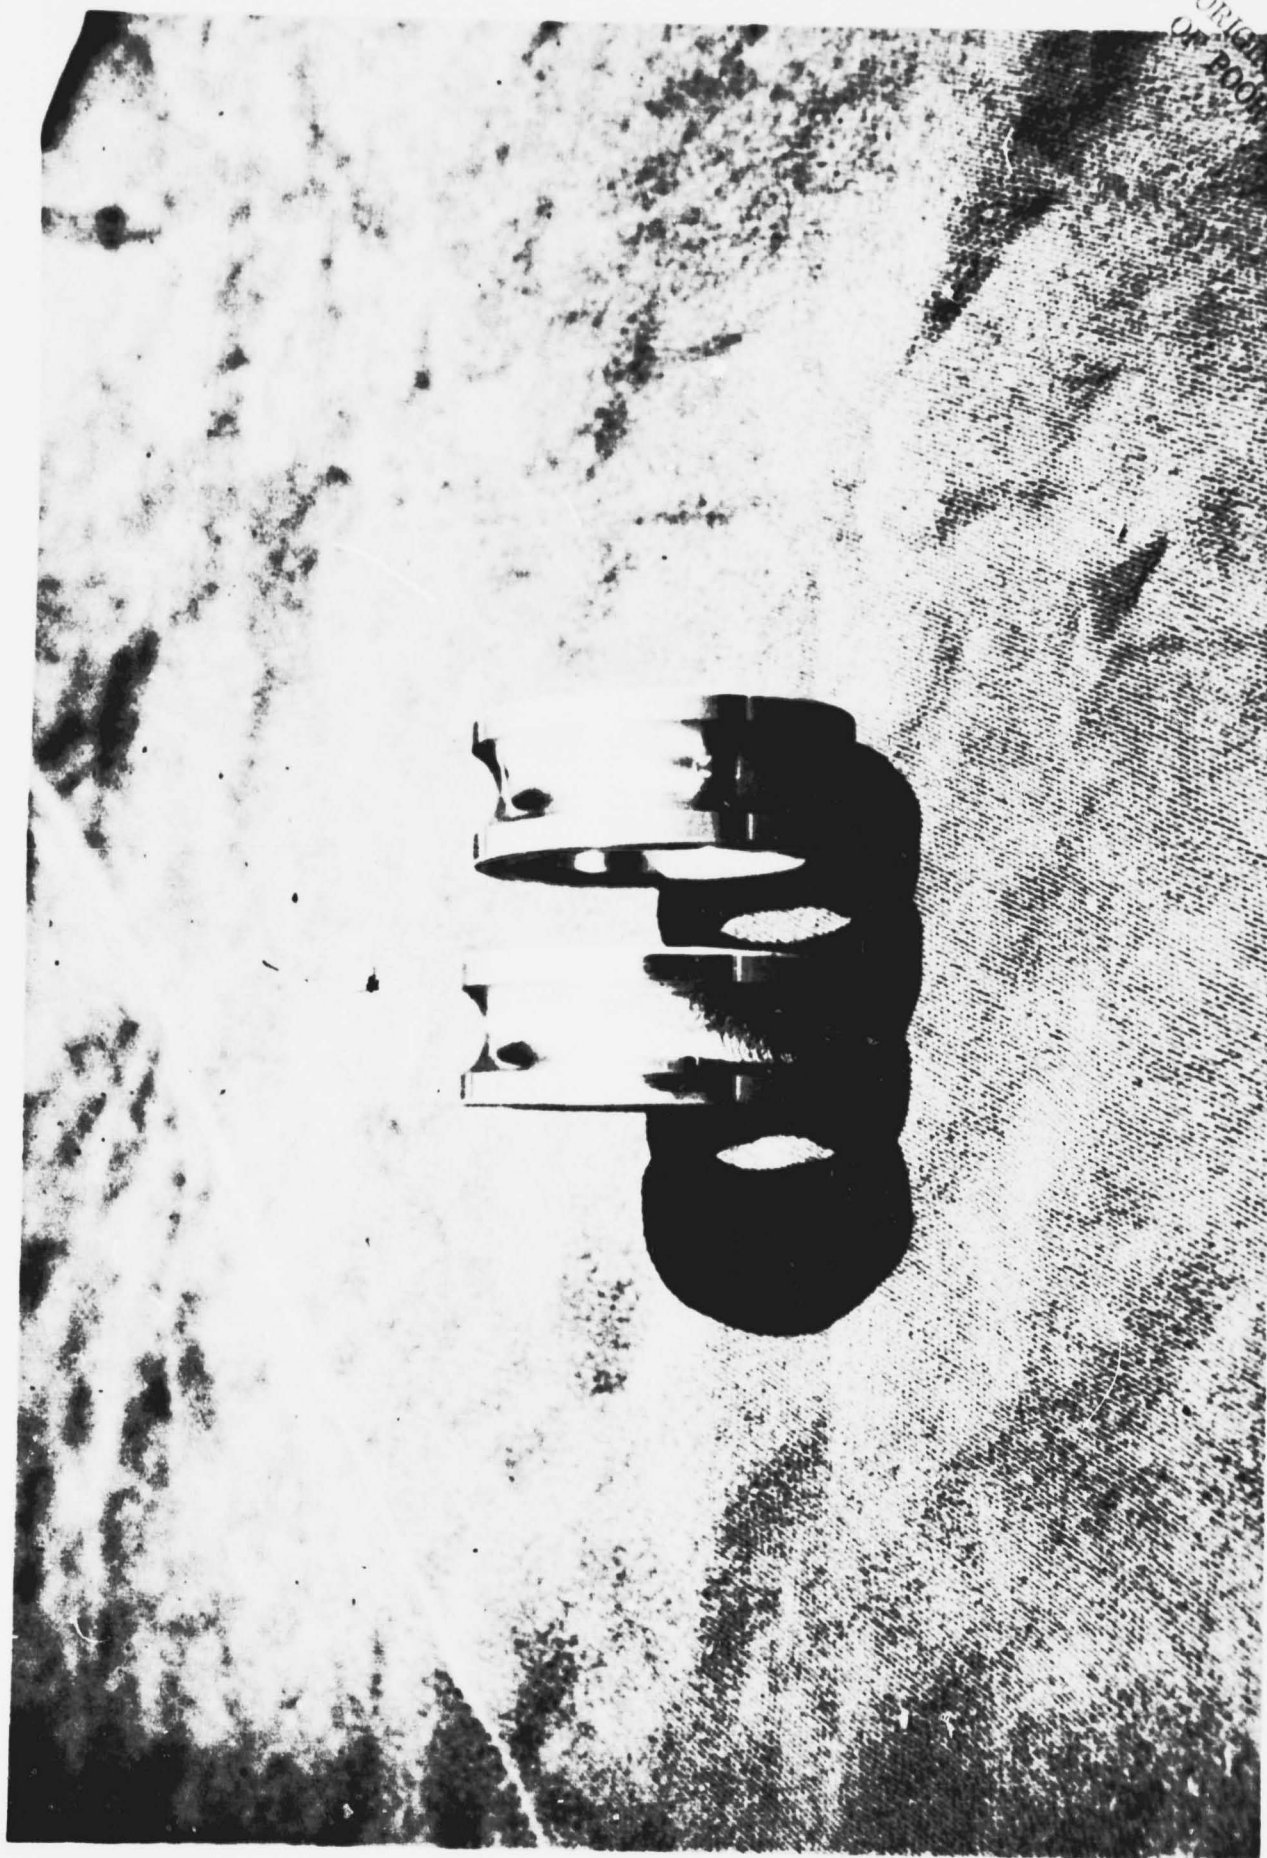
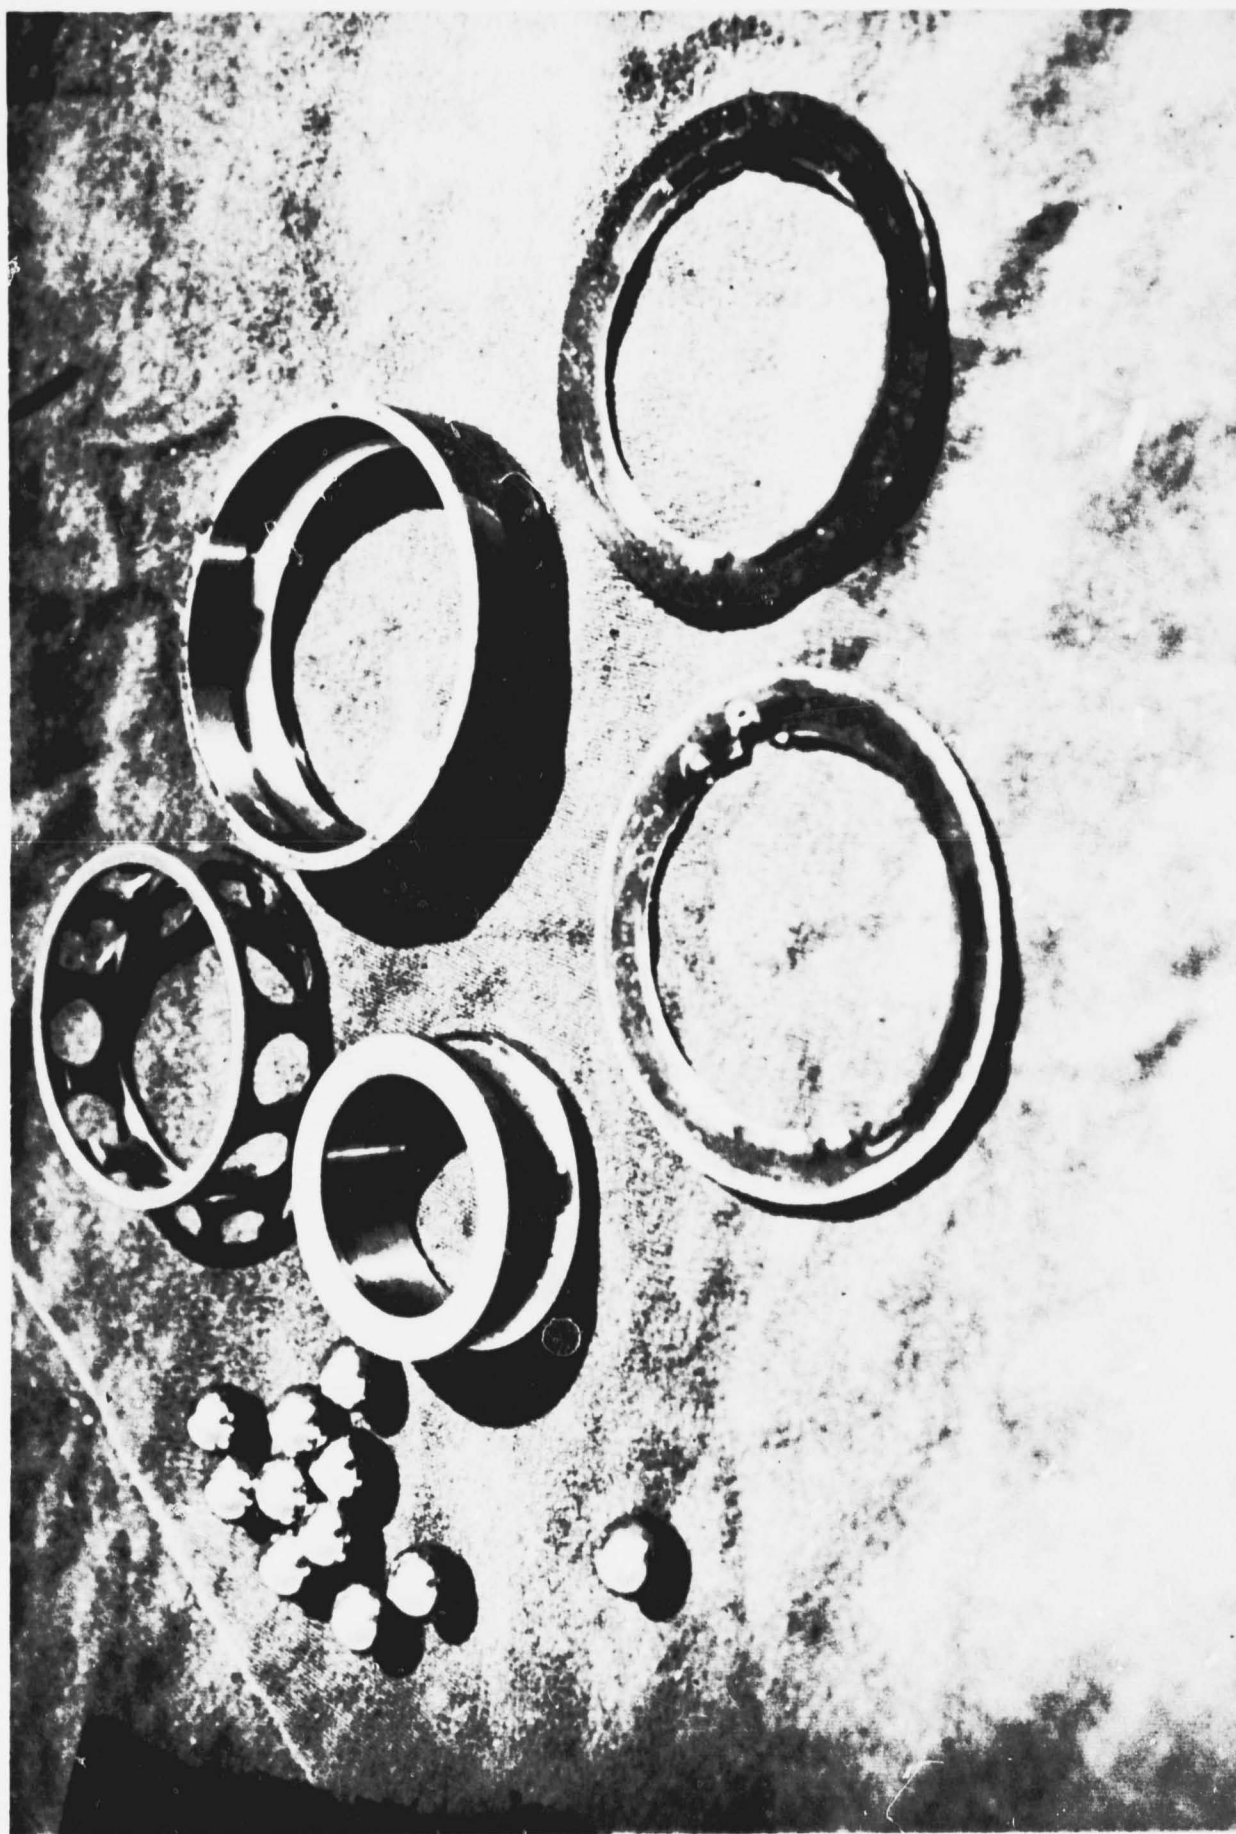
The bearings behind the main impeller had sustained heavy damage. The back bearing showed damage all around both inner and outer races, whereas the front bearing outer race showed damage only over the lower 180 degrees (with respect to pump orientation). The initial impression of this damage is that heavy loads, both radial and thrust, had been seen by the bearings.

FIGURE 29 - MAIN IMPELLER BEARING INNER RACE

FIGURE 30 - MAIN IMPELLER BEARING AND BELLVILLE WASHERS

The bearings on the main impeller shaft were severely worn. The inner races showed deep impact-type surface wear. On one inner race this extended over almost 360 degrees, with the most severe wear over about 150 degrees. This bearing was mounted on the shaft farthest from the impeller. The second inner race was damaged only over a 120-degree arc; this race was mounted nearest the impeller. The wear patterns suggest a severe radial load rotating with the impeller, possibly from imbalance. They do not suggest a thrust load. The outer races were lightly worn over their entire periphery. Wear patterns on the inner races are sketched below and photographed in Figures 29 and 30.

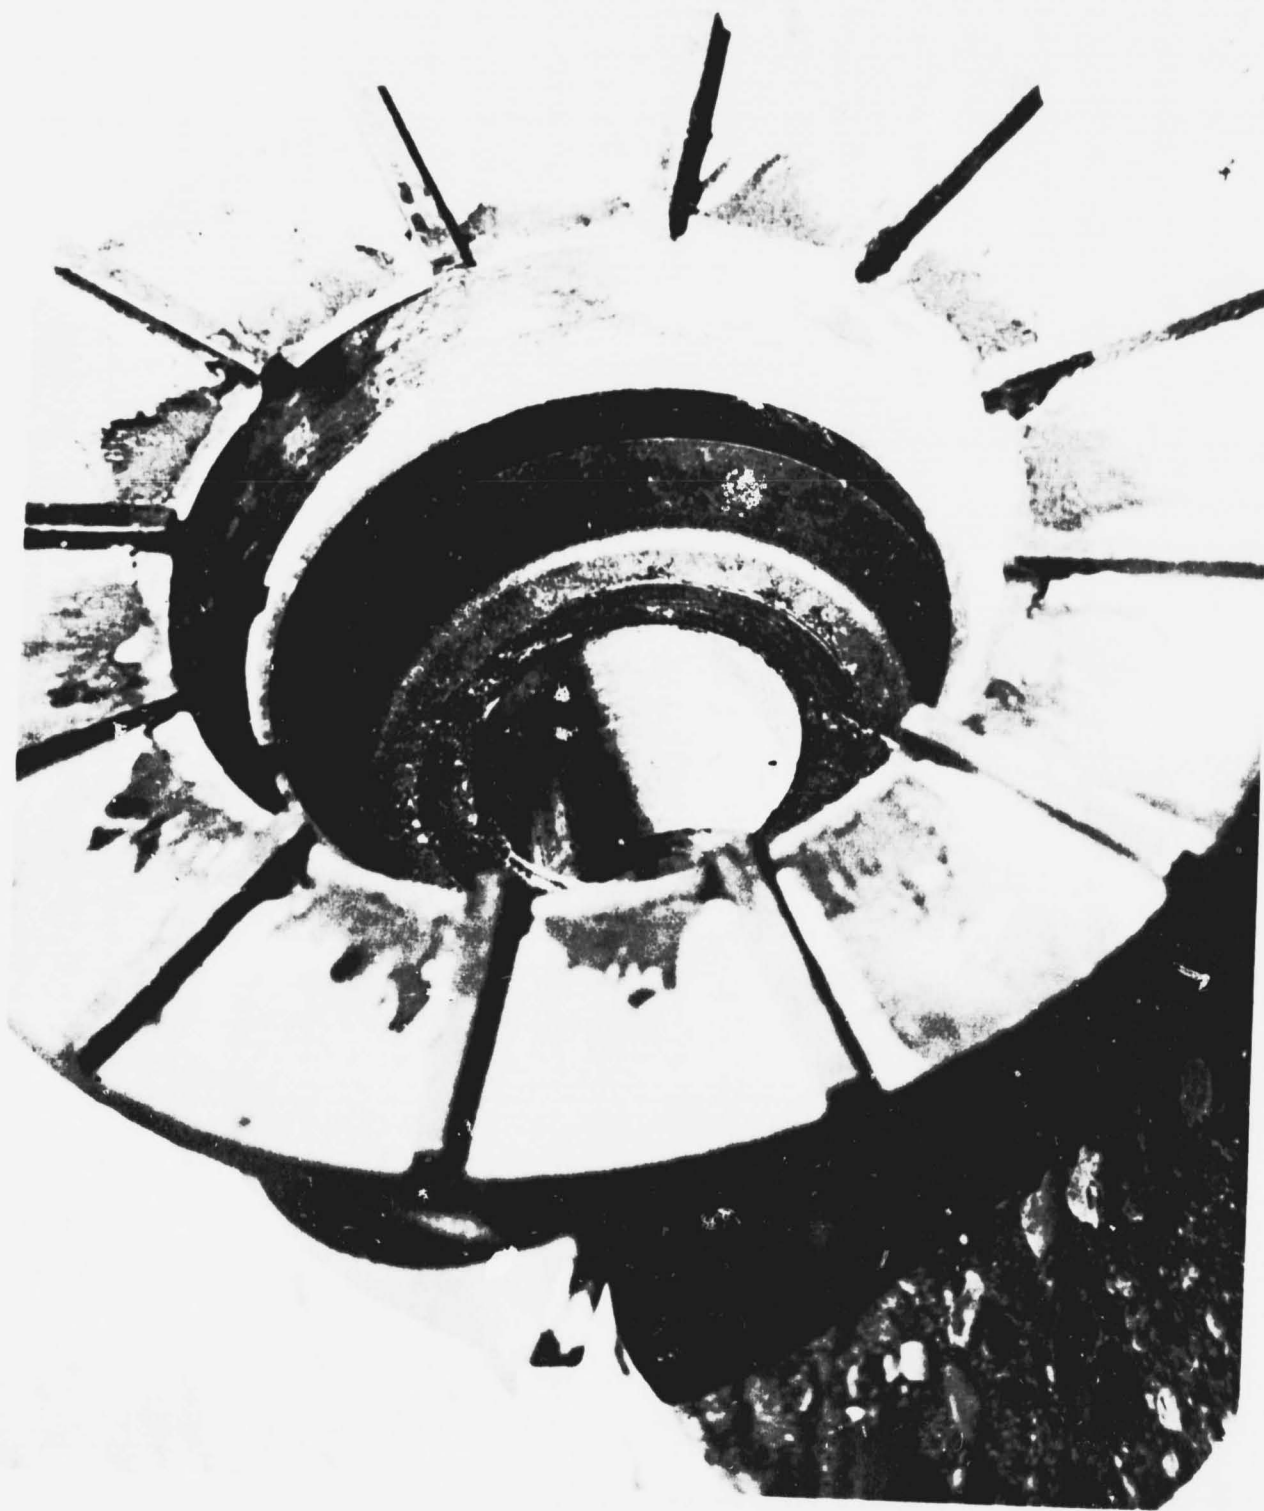
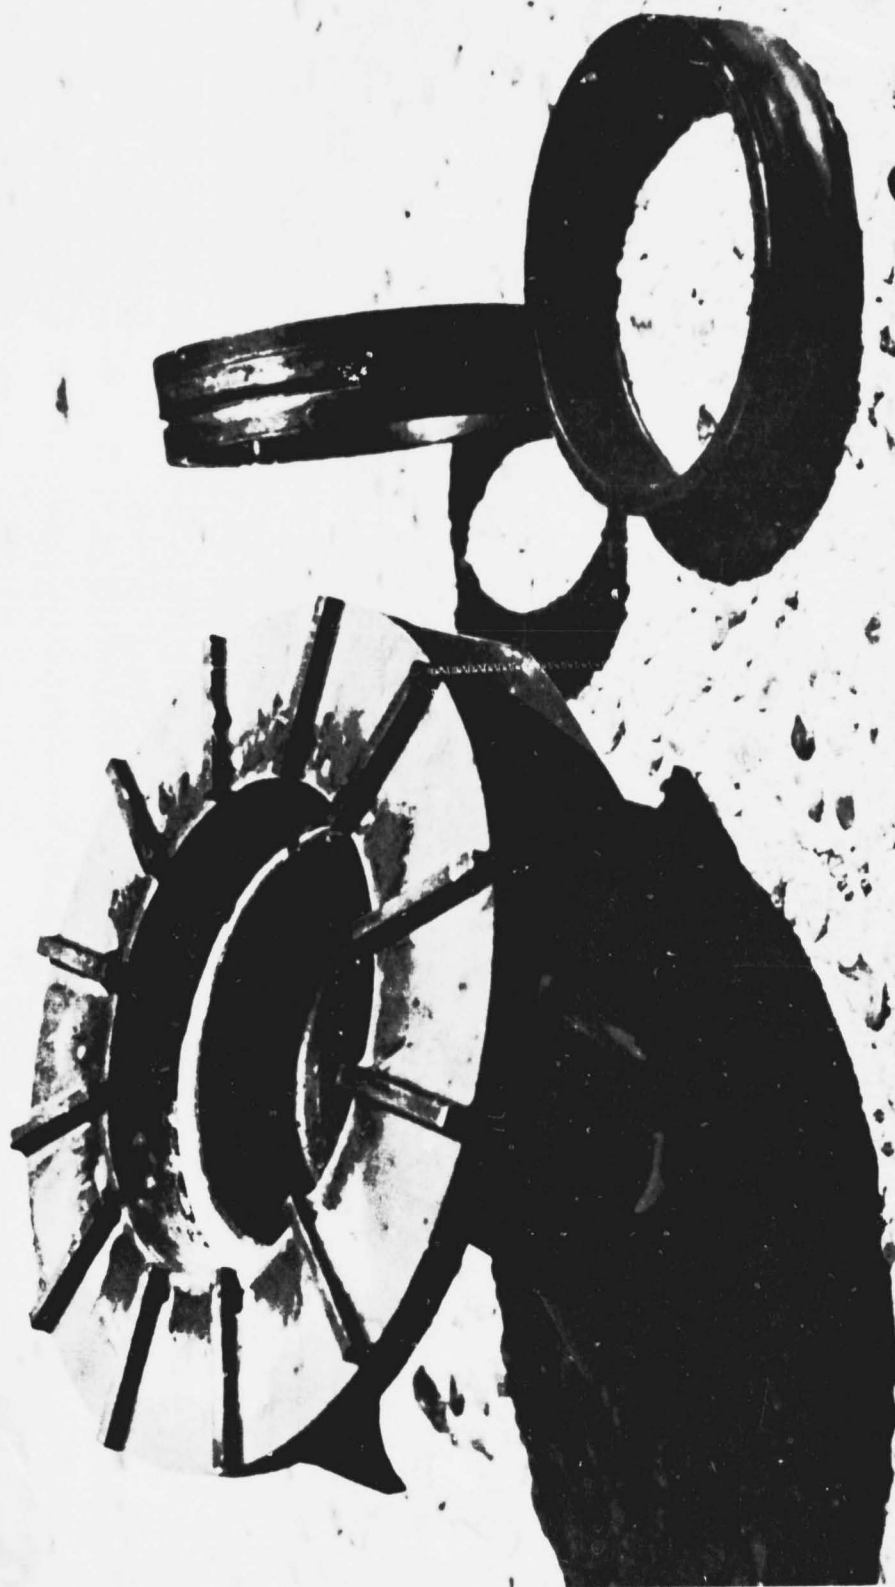
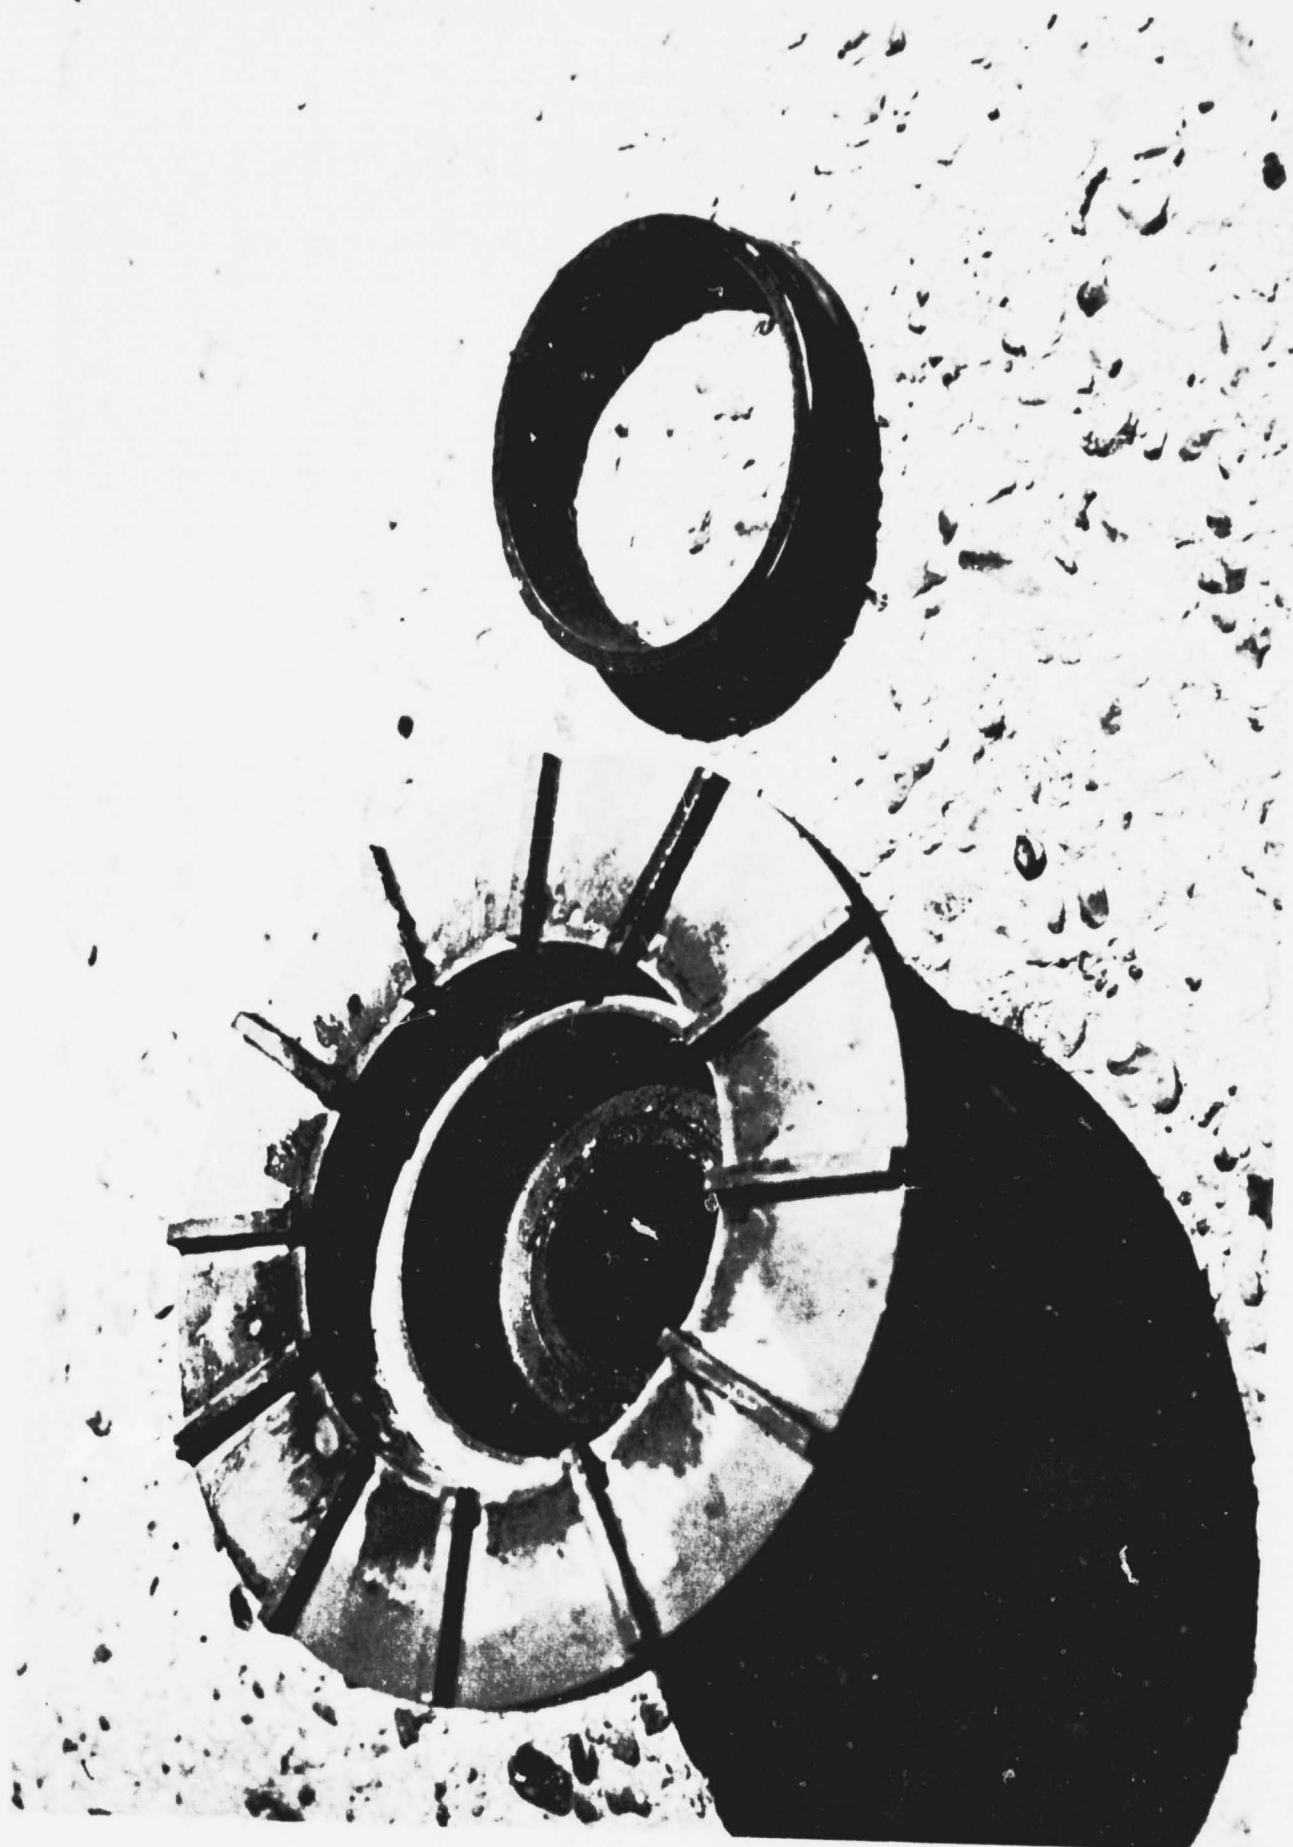
FIGURE 31 - MAIN IMPELLER

FIGURE 32 - MAIN IMPELLER AND SEAL RING

FIGURE 33 - MAIN IMPELLER AND SEAL RING

The main impeller seal (piston-ring type) was severely damaged. This seal consists of a stainless-steel seal ring mounted on the volute, a stainless-steel running ring mounted in the impeller, and a Teflon-carbon piston ring that rides in a groove in the seal ring. Upon disassembly, it was found that the running ring had become detached from the impeller and (apparently) attached to the seal ring; it had worn the impeller sufficiently to open a clearance of approximately 0.020 inch. The piston ring had completely disintegrated and disappeared. Both the stainless rings and the impeller were corroded and stained. See sketch below and Figures 31, 32, 33.

It is inferred that the running ring had been stationary for many hours of operation. Wear marks on both impeller and running ring were obliterated by corrosion.

1. Wear of the running-ring bore associated with the seal failure described above (Figs 31, 32, and 33).
2. Very slight scoring of the shroud. This was so minor as to leave the anodized coating intact, with minor exceptions.
3. A small area of cavitation pitting on the pressure surface of each blade about an inch from the trailing edge and half an inch from the hub (see sketch below and Fig 34).

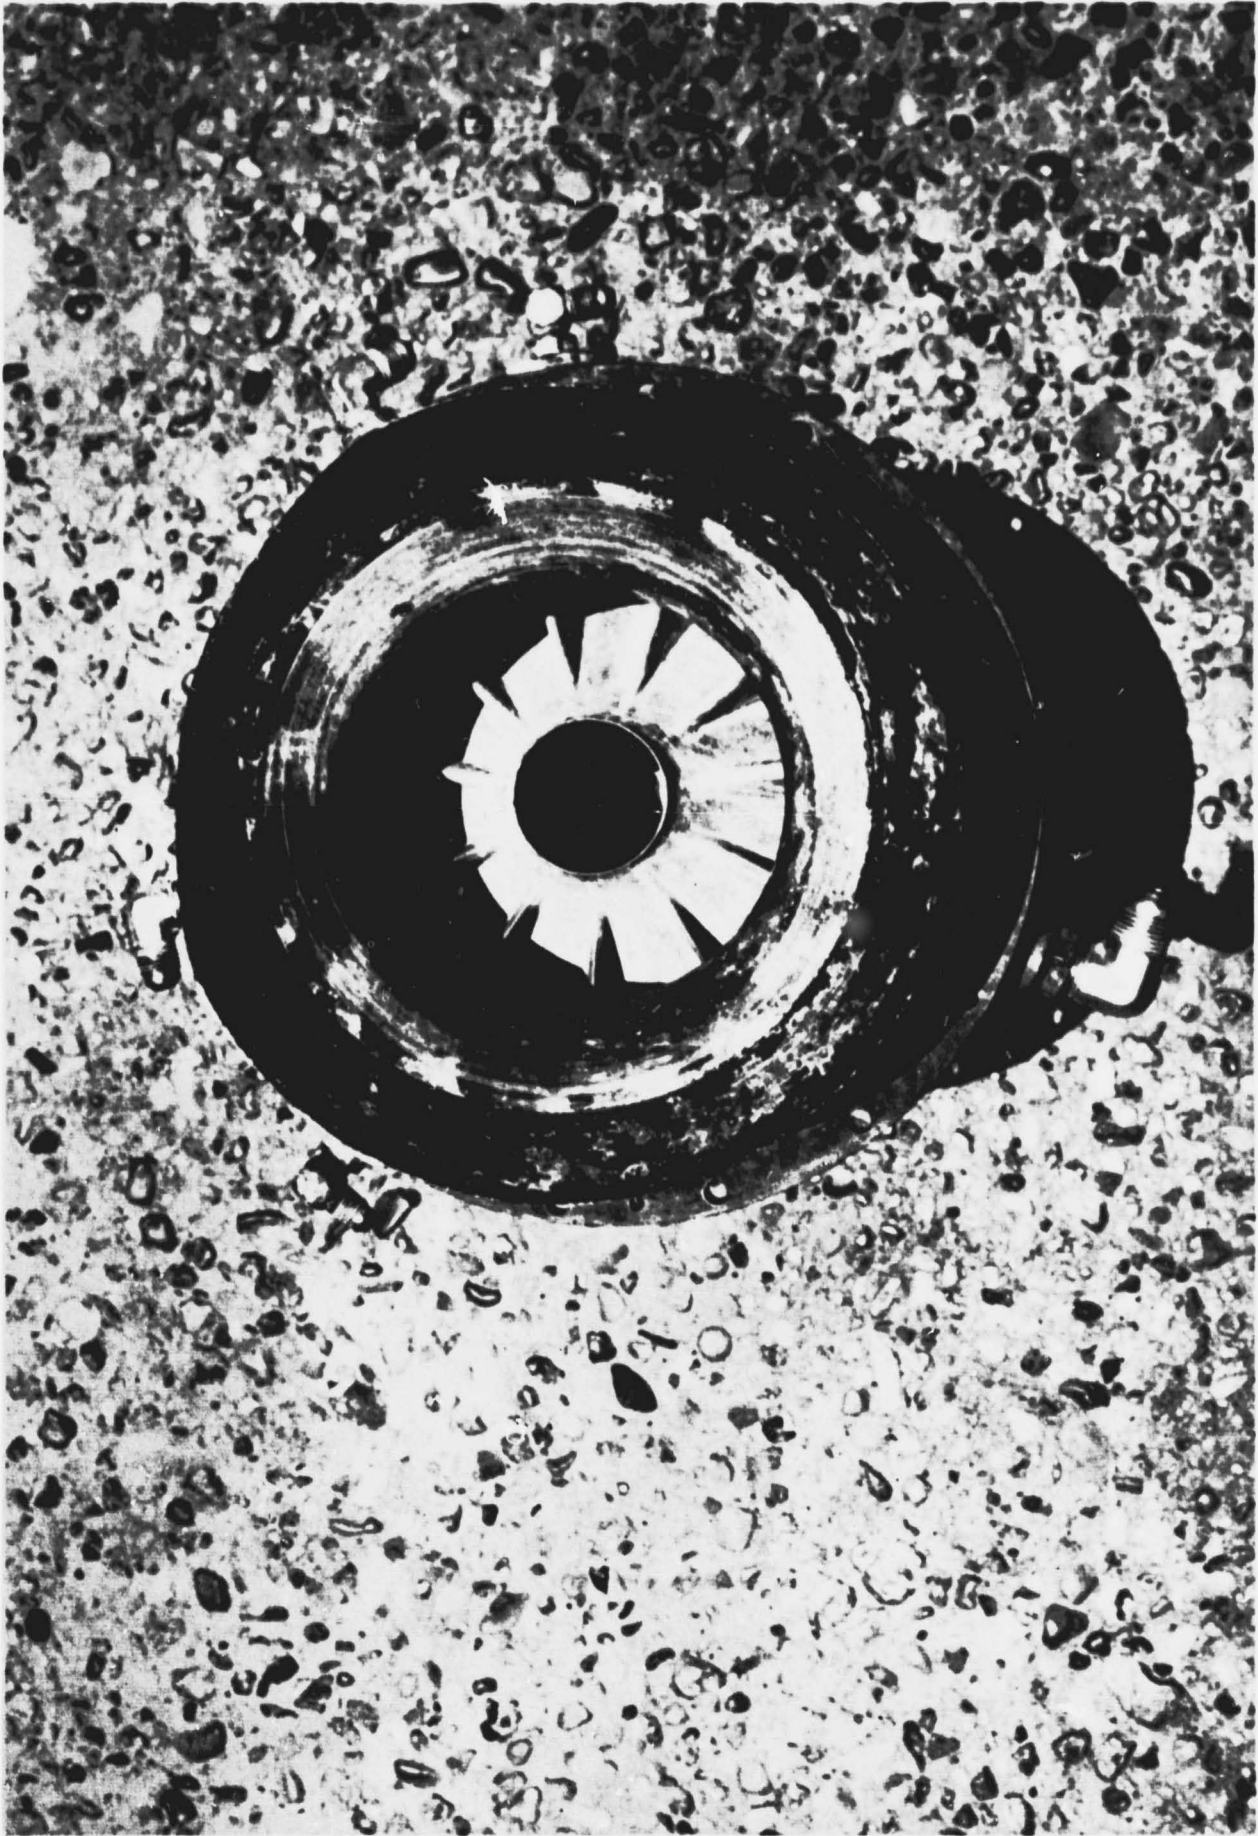
FIGURE 36 - INDUCER HOUSING, MAIN IMPELLER SHROUD

There was surface abrasion to the inducer housing in two locations: on the inducer shroud near the inlet to the inducer blading and on the main impeller shroud near the impeller discharge. The abrasion in the inducer shroud was damage sustained during endurance testing at NREC in September, 1978, when two inducers developed cracked blades and rubbed the shroud. This abrasion did not appear to worsen during the Coast Guard's test program.

The abrasion on the main impeller shroud covered approximately 1 1/2 inches along the shroud from the impeller tip inwards and was nowhere more than a few thousandths of an inch deep. This abrasion was probably associated with and a consequence of the bearing wear described above. See the sketch on the following page and Figure 36.

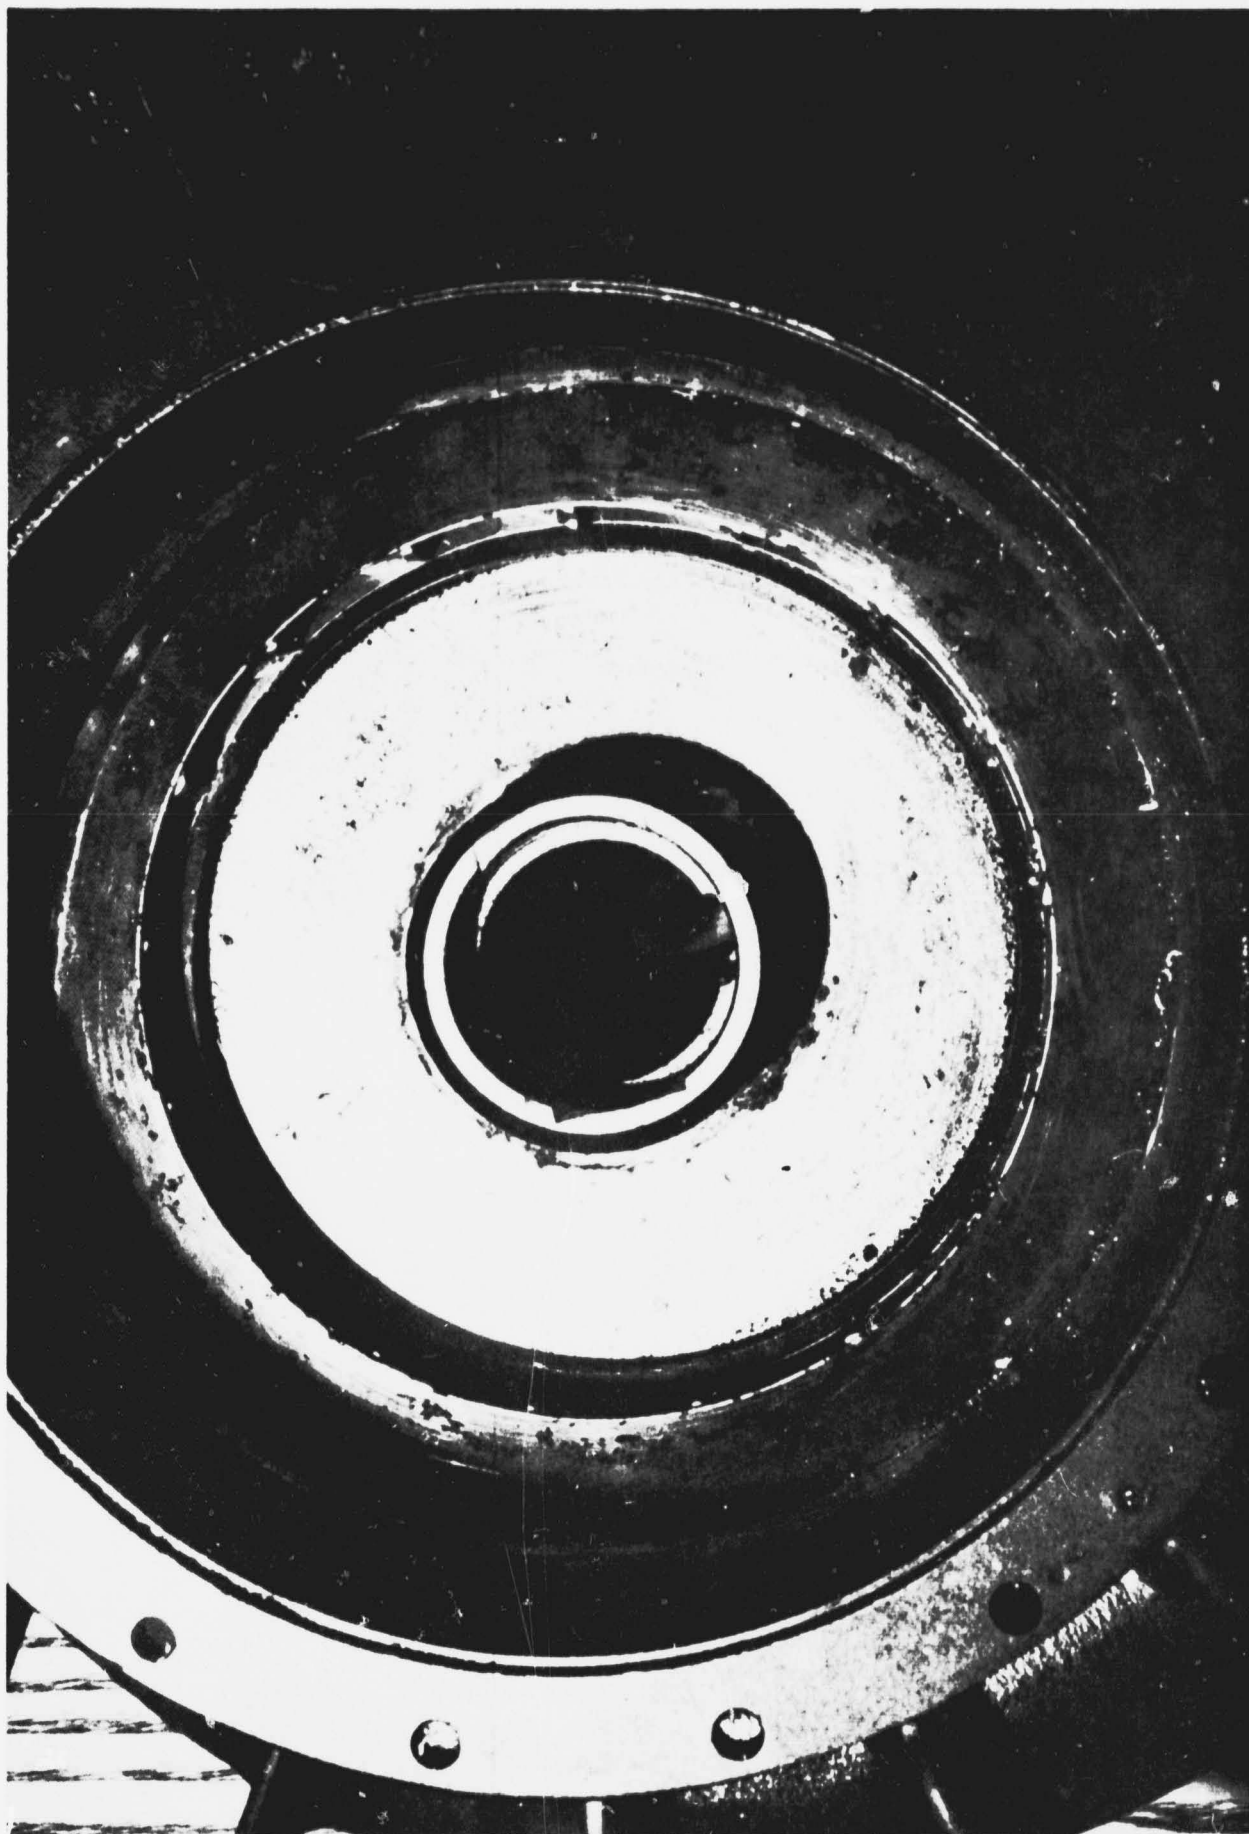
FIGURE 37 - VOLUTE, IMPELLER BACK SURFACE

The pump volute appeared to be in good condition. The anodized coating was intact. There was some minor evidence of corrosion pitting on a microscopic scale (Fig 37). The bearing bore proved to be undersize by approximately 0.005 inch at the location of the inner main impeller bearing. As this condition did not exist at the time of assembly, it is inferred that heat developed in the seal rings at the time of the seal failure described above may have caused the aluminum to creep under pressure from the shrink-fitted seal ring. When the seal ring was removed from the volute, some distortion of the faying surface was noted, supporting this conjecture. Other views of the volute are shown in Figures 38 and 39.

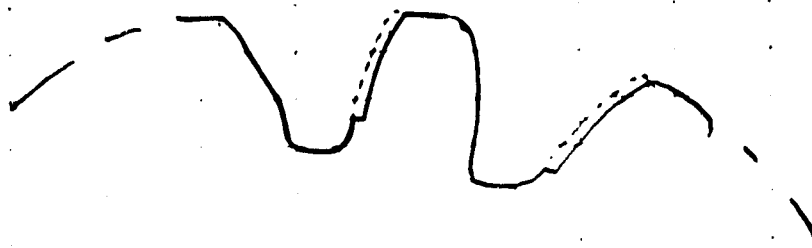
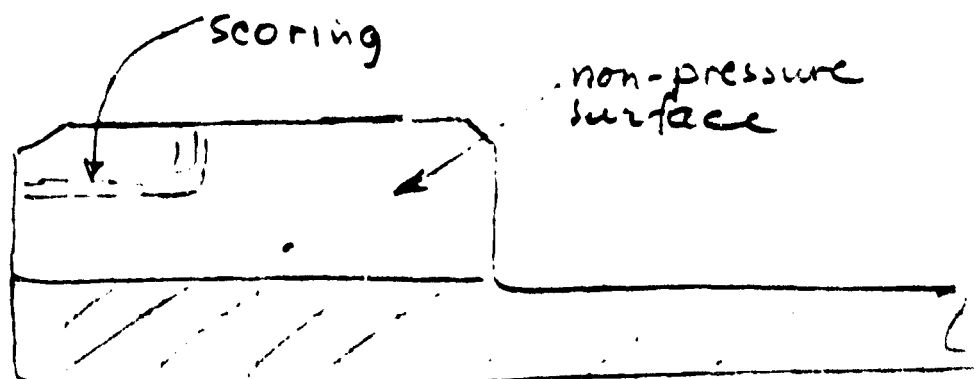
The pump end of the quill shaft was in excellent condition and showed no appreciable wear. The engine end of the quill shaft was severely worn: the pressure faces of the spline teeth were uniformly worn and polished from the tips to about 0.030 inch from the root fillet (see sketch below). There was no evidence of wear on the engine spline.

About one third of the spline teeth on the engine end had scoring on the non-pressure side near the end of the spline (see sketch on the next page).

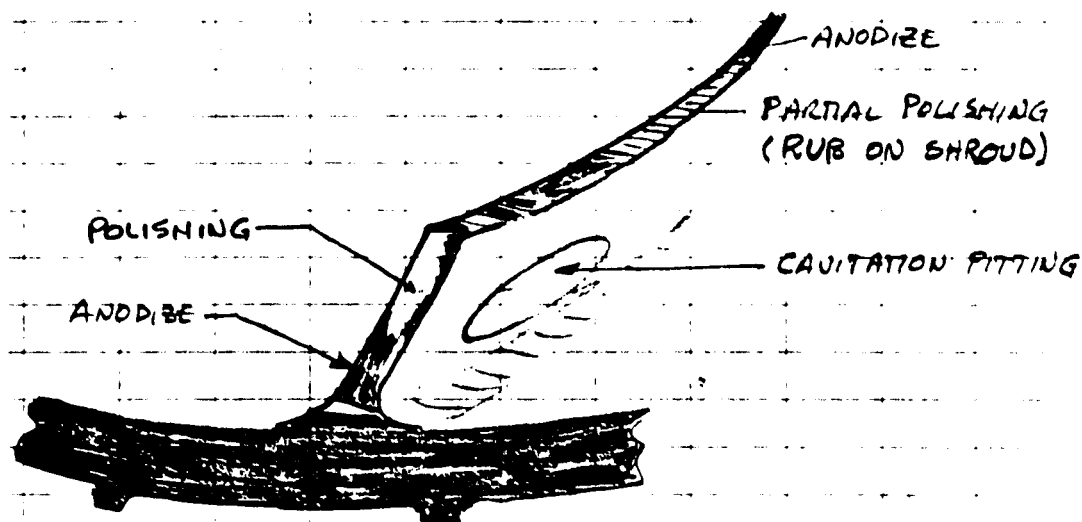
Typical Impeller Appearance

4. Partial polishing of blade tips (cylindrical surface), sufficient to remove anodizing (see sketch below and Fig 34).
